**DRAFT FINAL REMEDIAL ACTION PLAN  
PETALUMA QUARRY PROPERTY  
PETALUMA, CALIFORNIA**

August 2, 2005

Kleinfelder Project No: 48912  
August 2, 2005

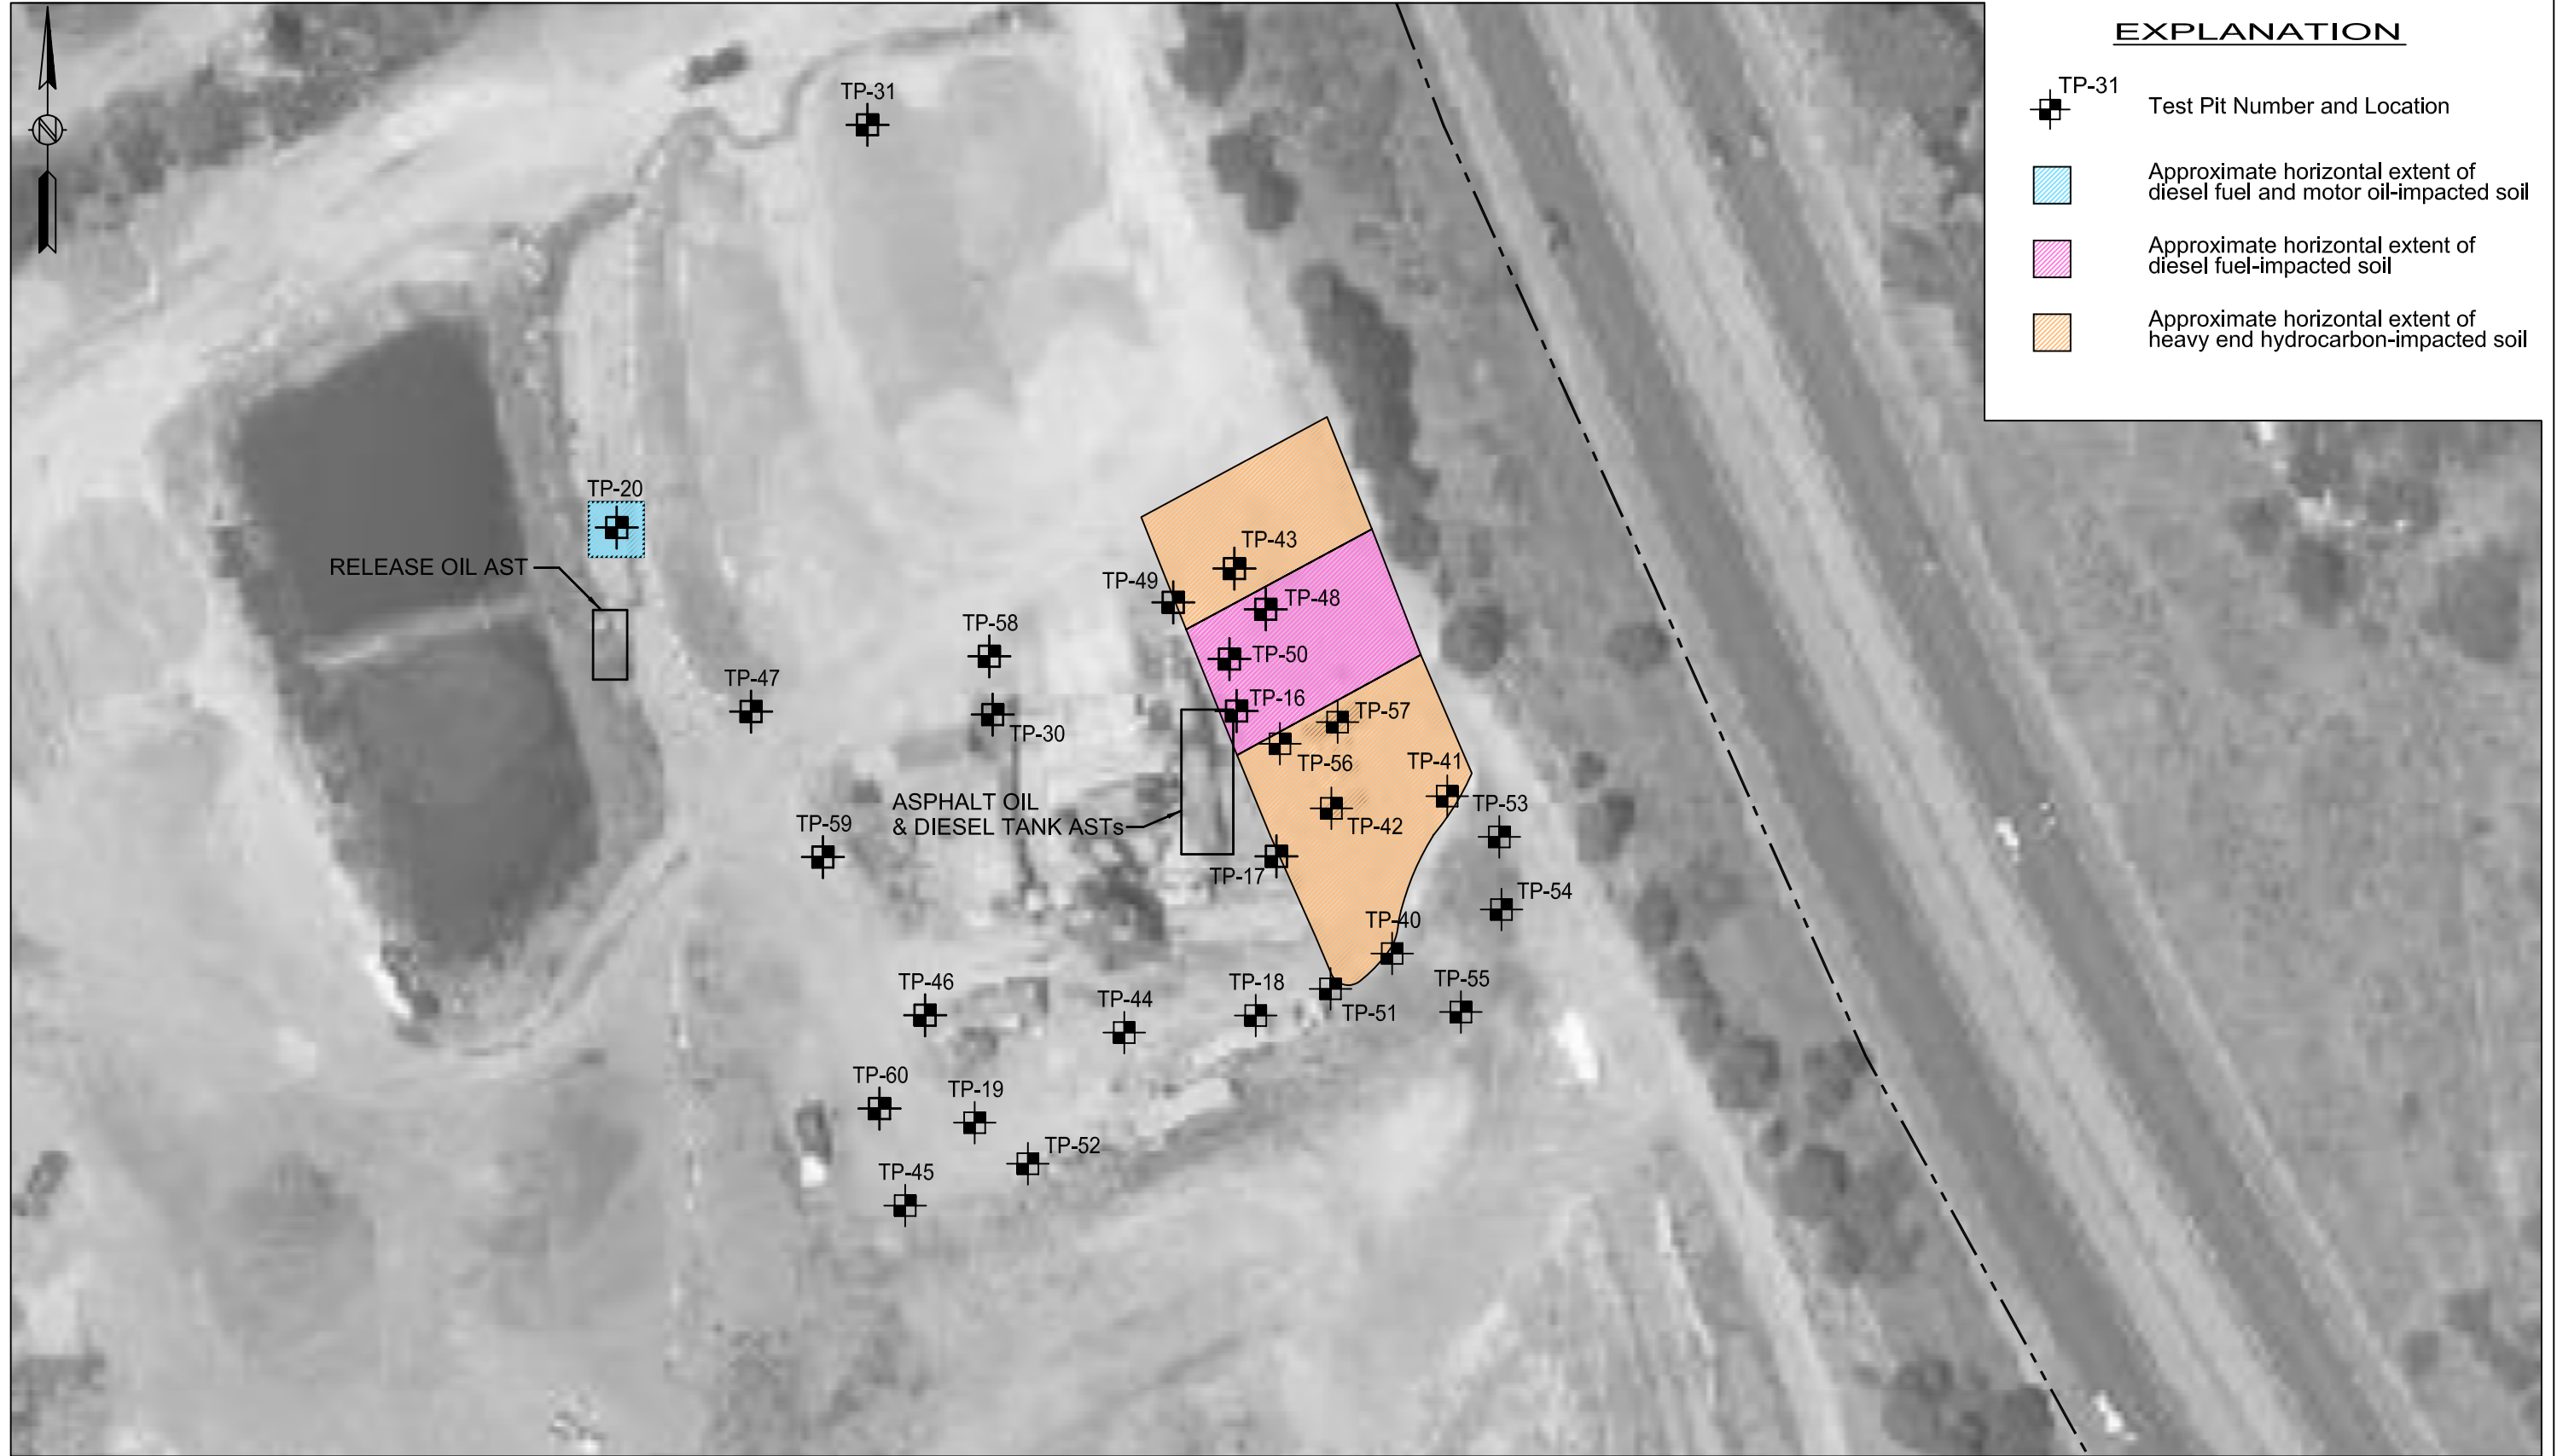
**1**

| Plate 1 | Site Plan and Sampling Locations |

The Site has been developed for use as a quarry since at least the early 1900s. According to historical records and title reports, San Rafael Rock Quarry purchased the Site from American Rock, Inc. sometime in the early 1990s. While rock mining operations ceased in about 1993, the Site currently supports aggregate storage, classification and sale, settling pond, and asphalt production activities. Offices, an asphalt plant, settling ponds, various above ground storage tanks (ASTs) associated with Site operations, and concrete recycle piles currently occupy the Site (Plate 1).

The diesel fuel appears to affect soil within an area approximately 80-feet-long by 40-feet-wide (Plate 2). The release appears to be limited to a 5-foot depth where hard, coherent, impermeable bedrock is encountered. The heavy-end hydrocarbons appear to be restricted to the upper 2 feet of the soil profile within an area of approximately 80-feet-wide by 160-feet-long (Plate 2). These areas are slated for excavation and remediation.

The asbestos containing rock sample was collected from the serpentinite outcrop located on the southeastern slope of the central pit (see Plate 1 for the location of the central pit). This serpentinite outcrop extends from an elevation of approximately 35 to 75 feet mean sea level (msl). The asbestos containing soil sample was collected directly downslope of this outcrop. Development in this area will result in the burial of this serpentinite outcrop under approximately 25 (at the lowest elevation of the outcrop) to 65 feet (at the highest elevation of the outcrop) of fill.

On April 27, 2005, Kleinfelder collected near surface soil samples at the 11 sample locations DG-1 through DG-11 shown on Plate 1. Areas targeted for sampling include former locations of the maintenance shop, settling ponds, asphalt plant, concrete recycling plant, concrete crushing plant, brick plant, and the current locations of the concrete piles and release oil above-ground storage tank.
